# Lower Colorado River Multi-Species Conservation Program

## Backwater Inventory: Reaches 5 & 6 Step 1: Identification of Backwaters for Screening and Evaluation

## **Backwater Inventory: Reaches 5 & 6**

### **Step 1: Identification of Backwaters for Screening and Evaluation**

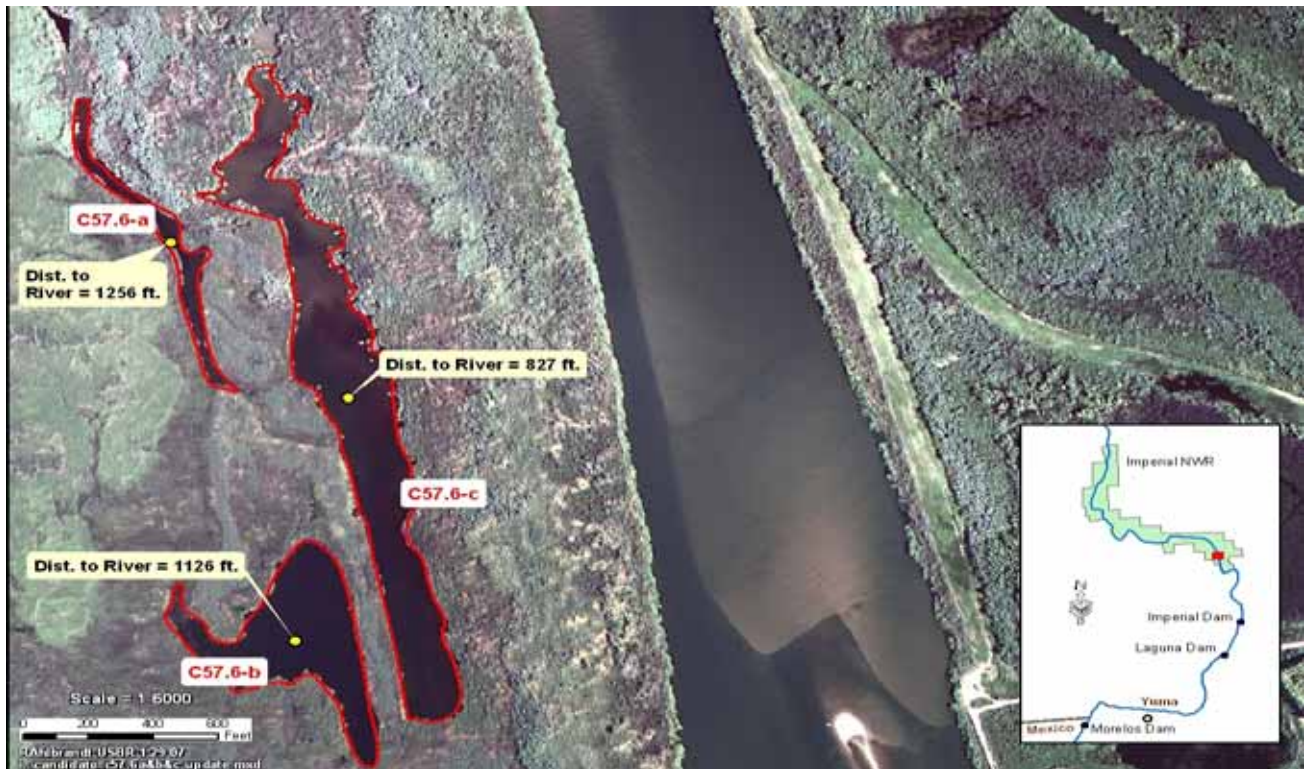
C57.6 comprises several isolated backwaters (15 ac total) on the California side of the Colorado River at river mile 59.5. The backwaters are isolated between the river and Ferguson Lake.

C57.6 exhibited moderately high salinity based on a water quality profile. Water clarity was moderate. Because of the elevated salinity, as well as the observed lack of connection to the river, C57.6 backwaters are classified as true seeps.

Site access to C57.6 is very limited. There does not appear to be any access by boat, road, or trail. C57.6 backwaters are within a no hunting/no fishing area, and are seasonally restricted from public access. No people were observed at C57.6 at the time of the helicopter survey.

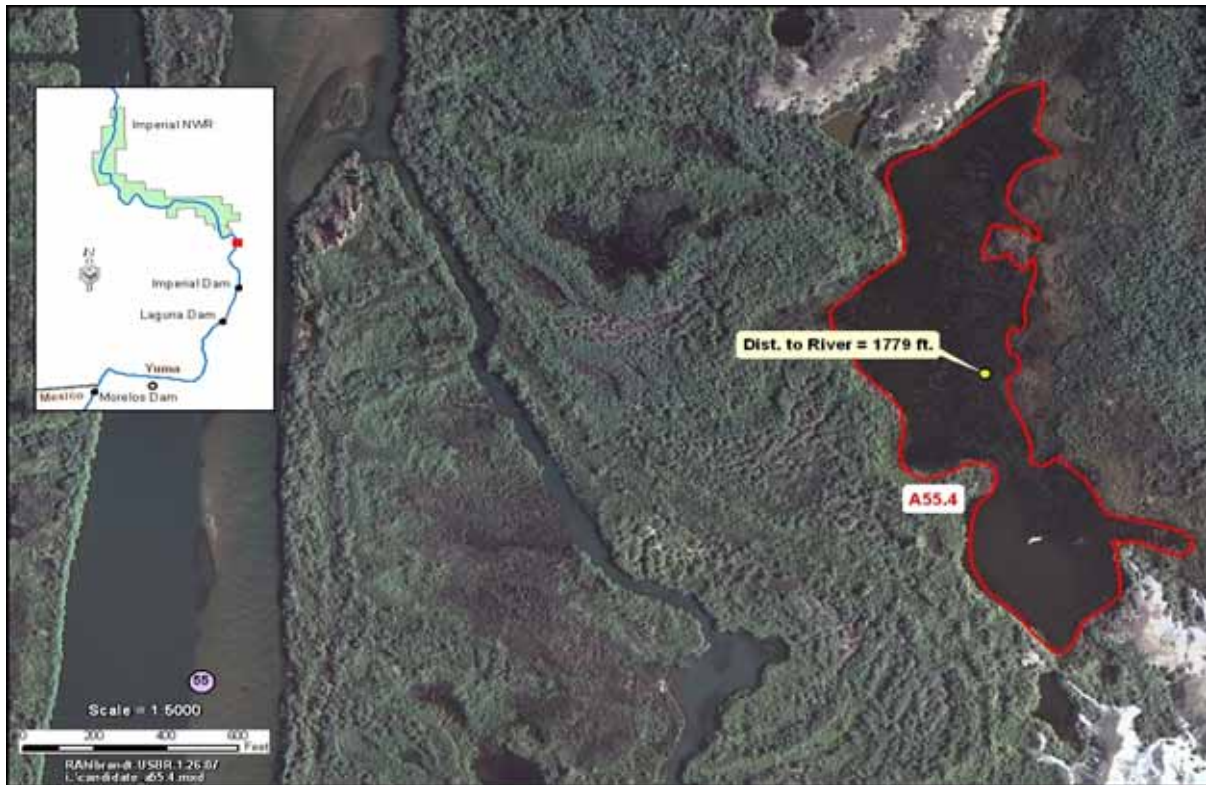
A55.4 is an indirectly connected backwater (14.3 ac) on the Arizona side of the Colorado River at river mile 55. The backwater appears to have been connected to the river via the dredged Arizona Channel, which has since become closed off from boat access by overgrown emergent vegetation.

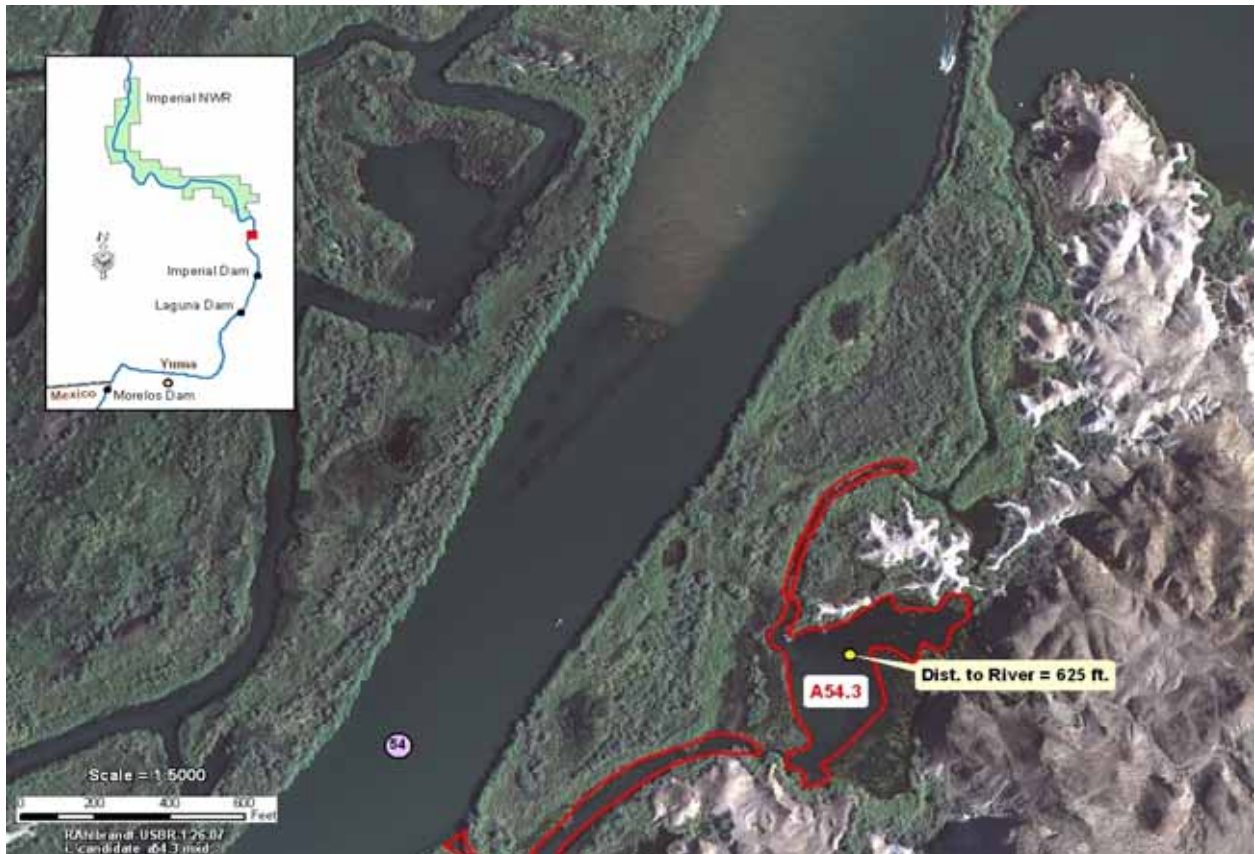
A54.3 is a directly connected backwater (3.2 ac) on the Arizona side of the Colorado River at river mile 54. A surface connection to the river potentially exists via an inlet channel; however, it may be possible to isolate this backwater.

Site access to A54.3 appears to be by boat only. Recreational use of this backwater is currently unknown, and would depend on site access. Public access is not restricted; however, no people were observed at A54.3 at the time of the helicopter survey. Recreational use is likely to be high, as is the case with most of the Arizona Channel backwaters, but would depend on boat access.

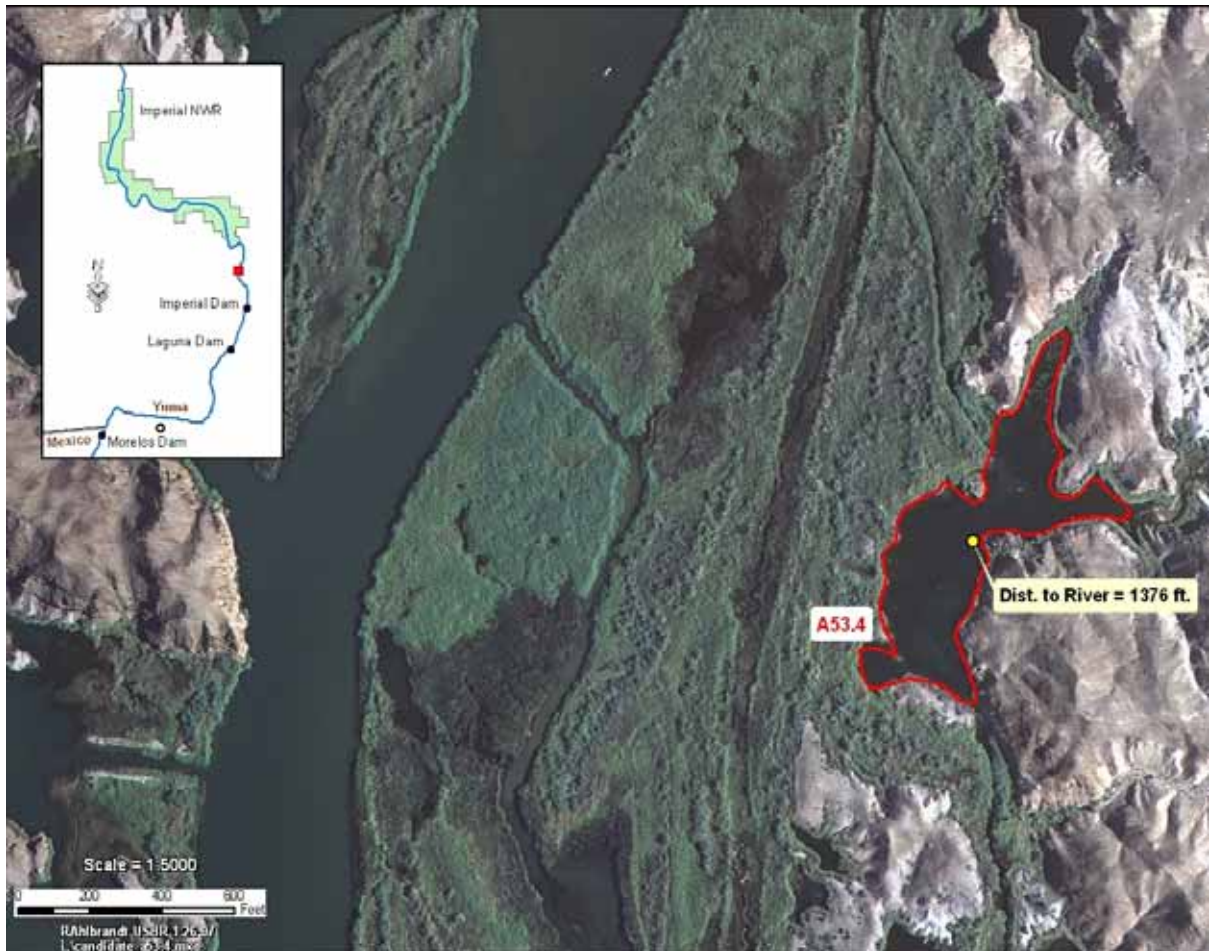
A53.4 is a directly connected backwater (4.8 ac) on the Arizona side of the Colorado River at river mile 53, and is classified a connected lake.

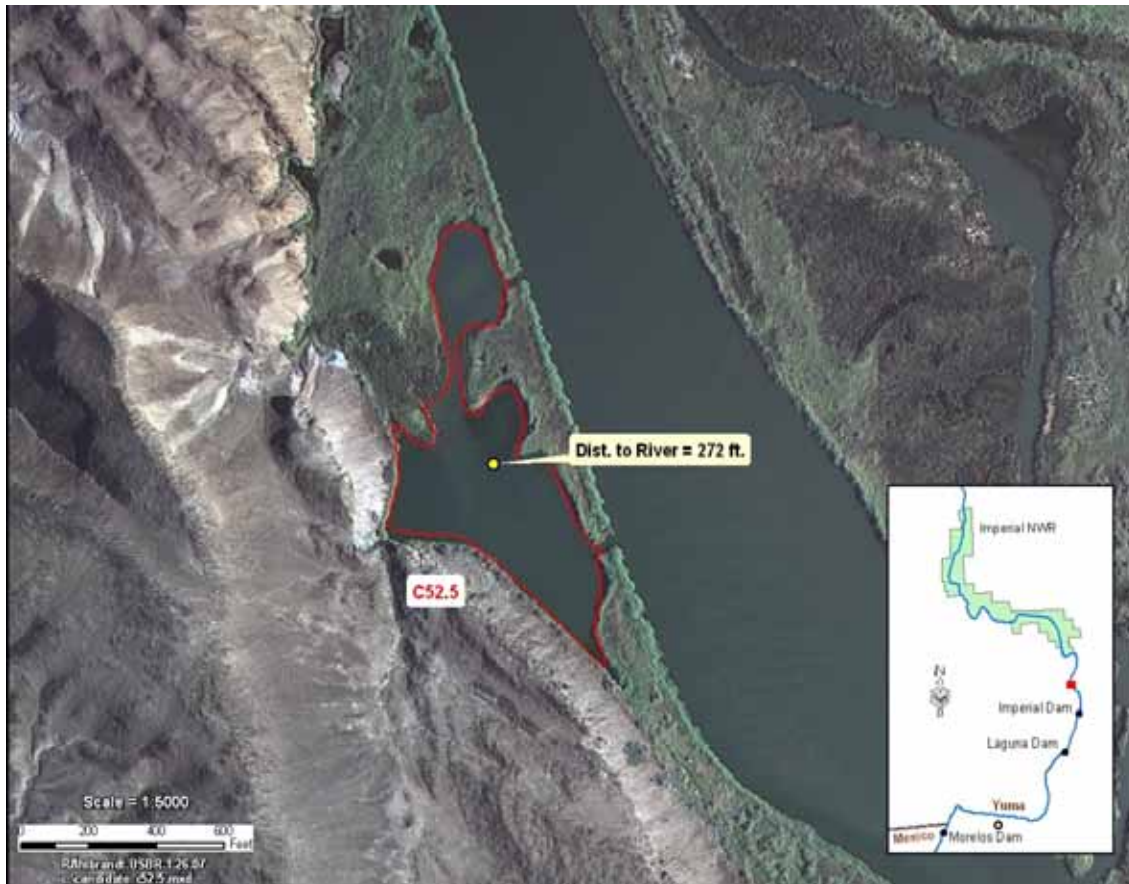
C52.5 is a directly connected backwater (6.5 ac) on the California side of the Colorado River. This backwater has an inlet channel that is accessible from the main river channel, which classifies the site as a connected lake. Because of the inlet to the backwater, the water quality is likely very similar to the river; however, no water quality profiles were conducted at the time of the helicopter survey.

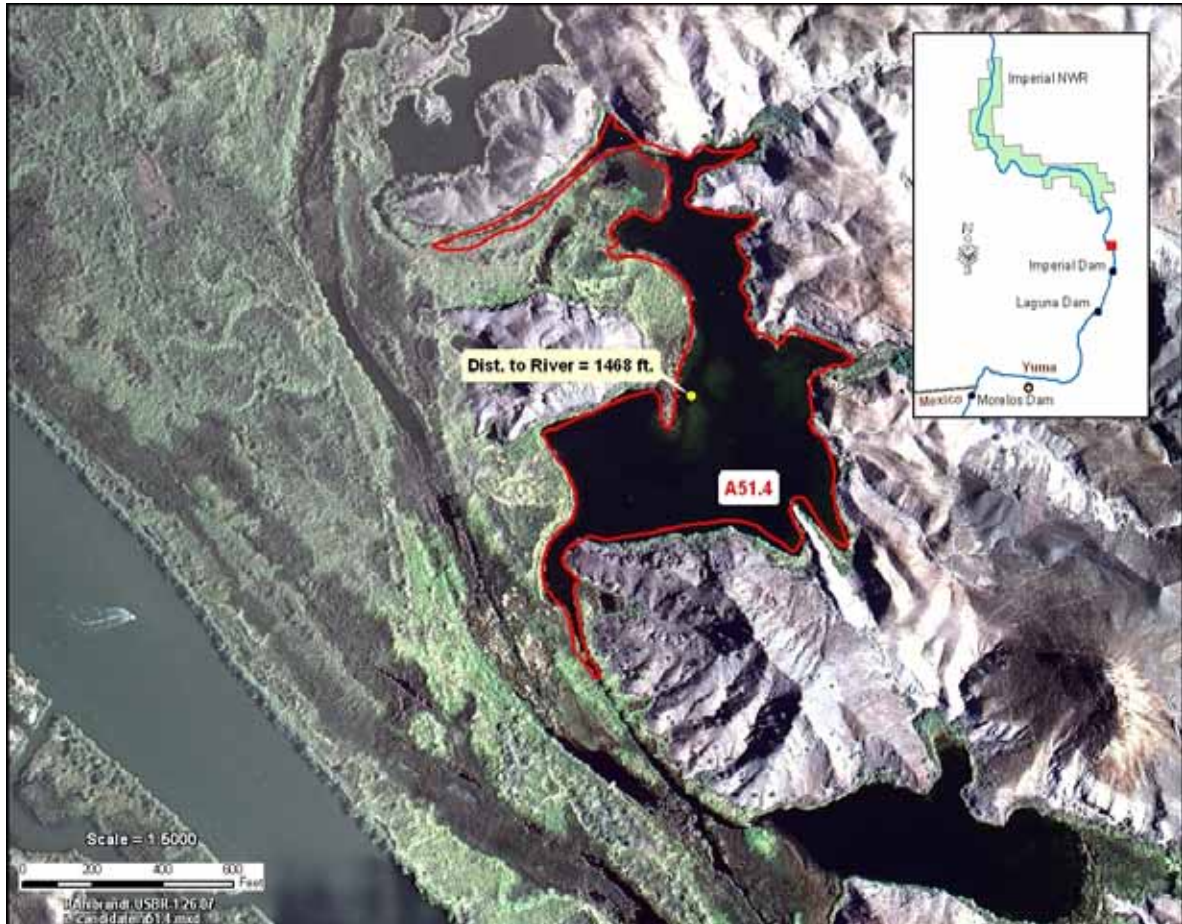
A51.4 is a directly connected backwater (10.8 ac) on the Arizona side of the Colorado River at river mile 52. The backwater appears to have been connected to the Arizona Channel, which connects numerous backwaters to the Colorado River via a dredged inlet channel. A51.4 is classified as a connected lake.

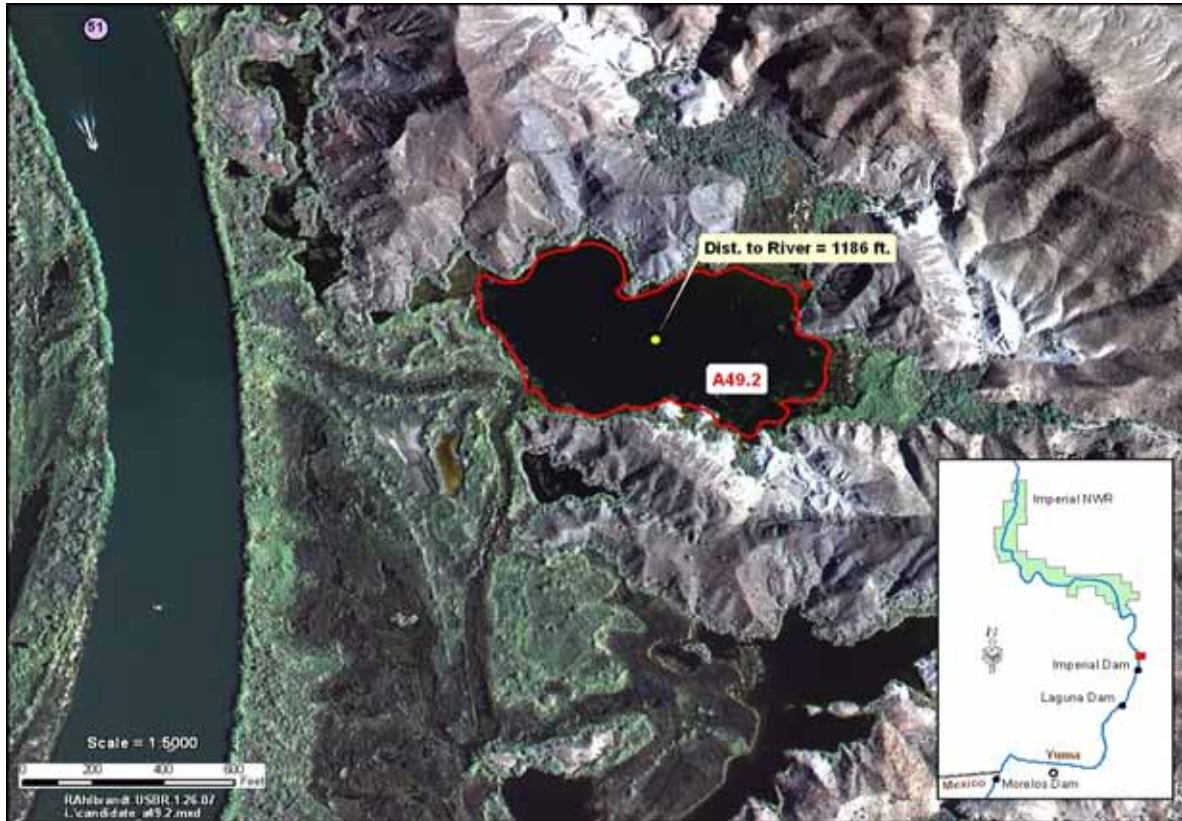
A49.2 is a directly connected backwater (8.5 ac) on the Arizona side of the Colorado River at river mile 50.5.

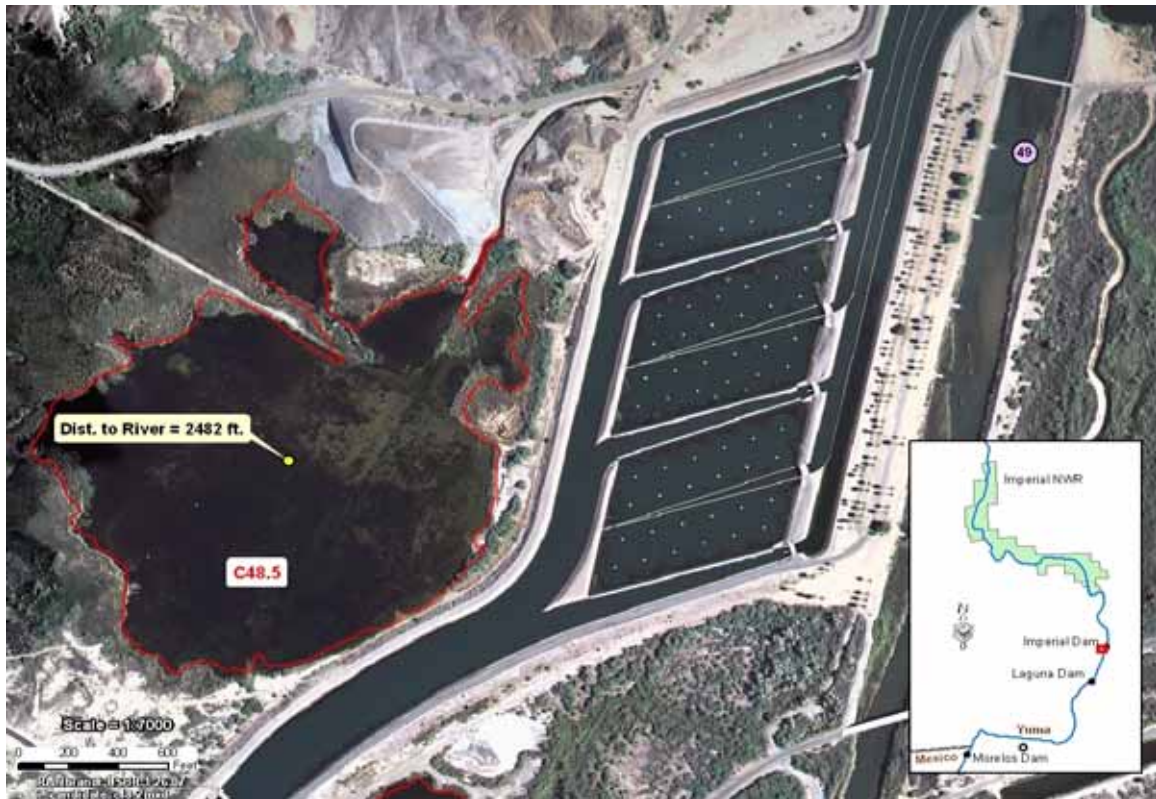
West Pond is located on the California side of the Colorado River, just west of the Imperial Dam Desilting Works. This backwater (52.1 ac) has no direct connection to the main river channel. The water source for West Pond is seepage from the All American Canal and Senator Wash (Kretschmann 2006) which classifies this backwater as a true seep.

Razorback suckers were stocked into West Pond from 1980 to 1983. During a survey in 1988, no razorback suckers were found; however, sport fish (largemouth bass, flathead catfish, sunfish) were present (Kretschmann 2006). Due to groundwater seepage and presence of sport fish, the water quality is likely to be suitable for native fish. No water quality profiles were conducted at West Pond during the helicopter survey.

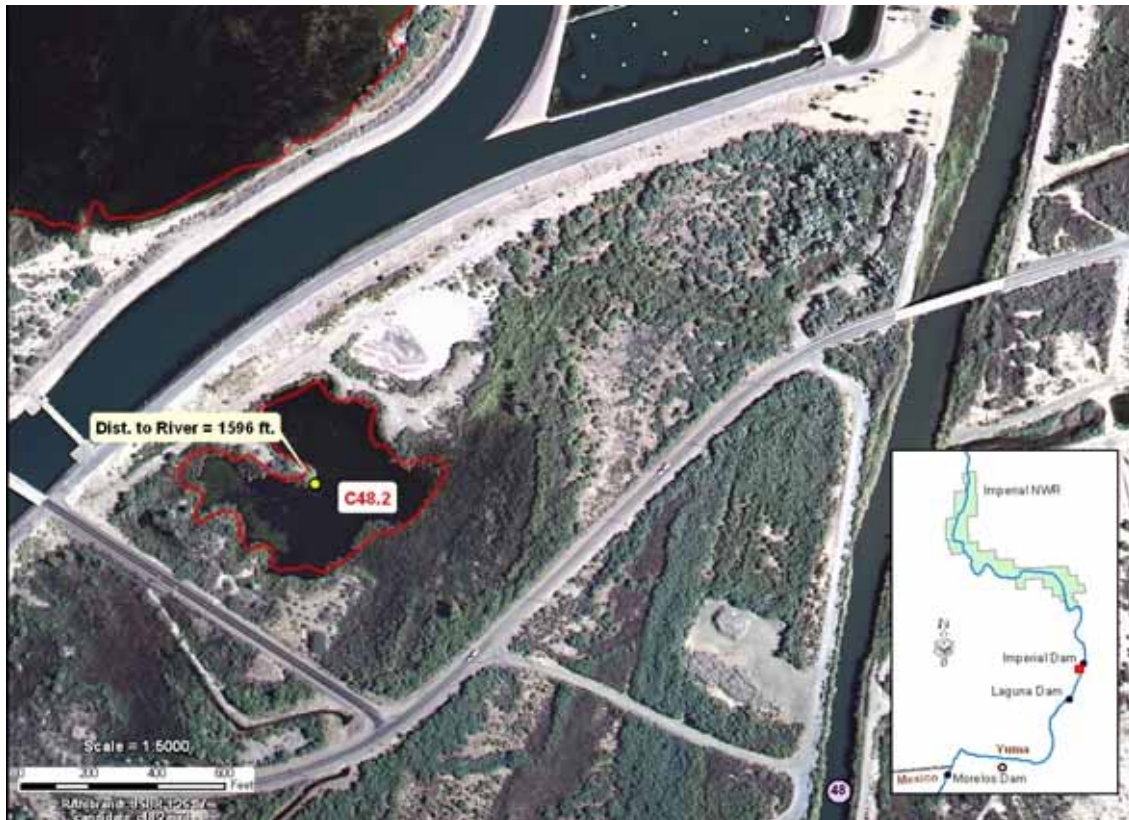
Horseshoe Pond is located south of the Imperial Dam Desilting Works, between the All American Cannel and the road to Yuma Proving Grounds. This backwater (5.4 ac) has no direct connection to the main river channel, which classifies this site a true seep. Most likely, the water source is seepage from the All American Canal.

During the time when razorback suckers were stocked into West Pond there was discussion regarding stocking razorback suckers into Horseshoe pond (Kretschmann 2006). No documentation was found that indicated razorback suckers were stocked into Horseshoe Pond. No water quality profiles were conducted at Horseshoe Pond during the helicopter survey.

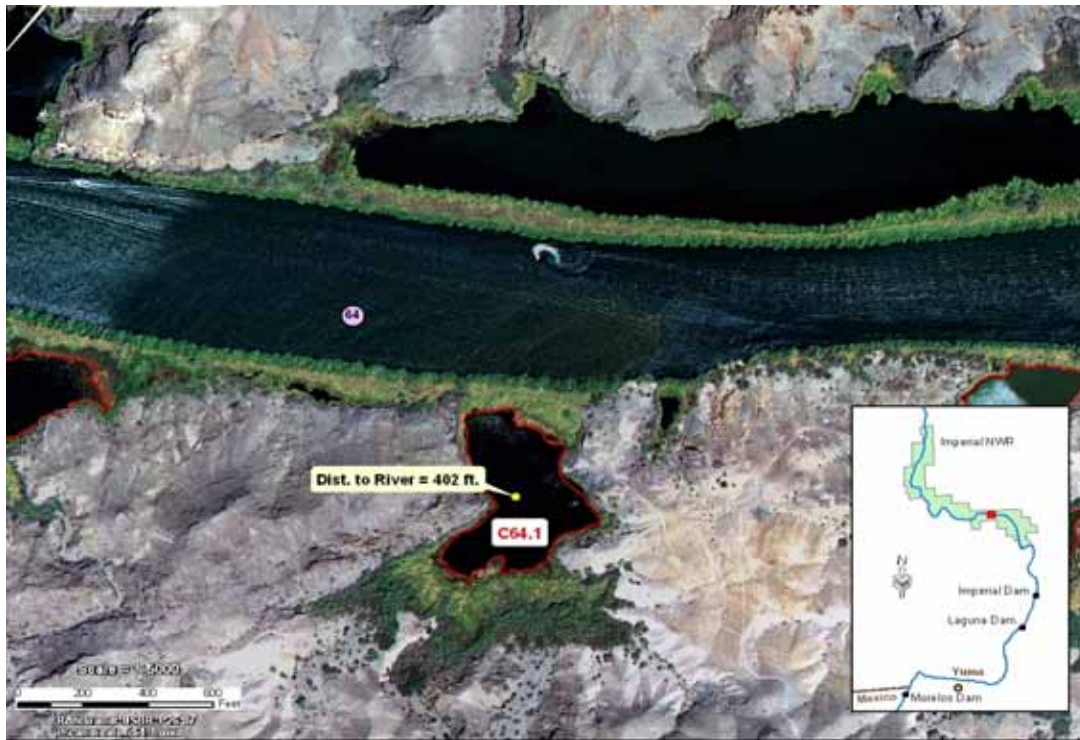
C64.1 is an indirectly<sup>3</sup> connected backwater (3.5 ac) on the California side of the Colorado River at river mile 64. During the helicopter survey, the backwater was 50% dry. Because this backwater appears to be connected to the river through a thick wall of emergent vegetation, it is preliminarily classified as a pseudo-seep. No water quality profiles were conducted at C64.1 during the helicopter survey.

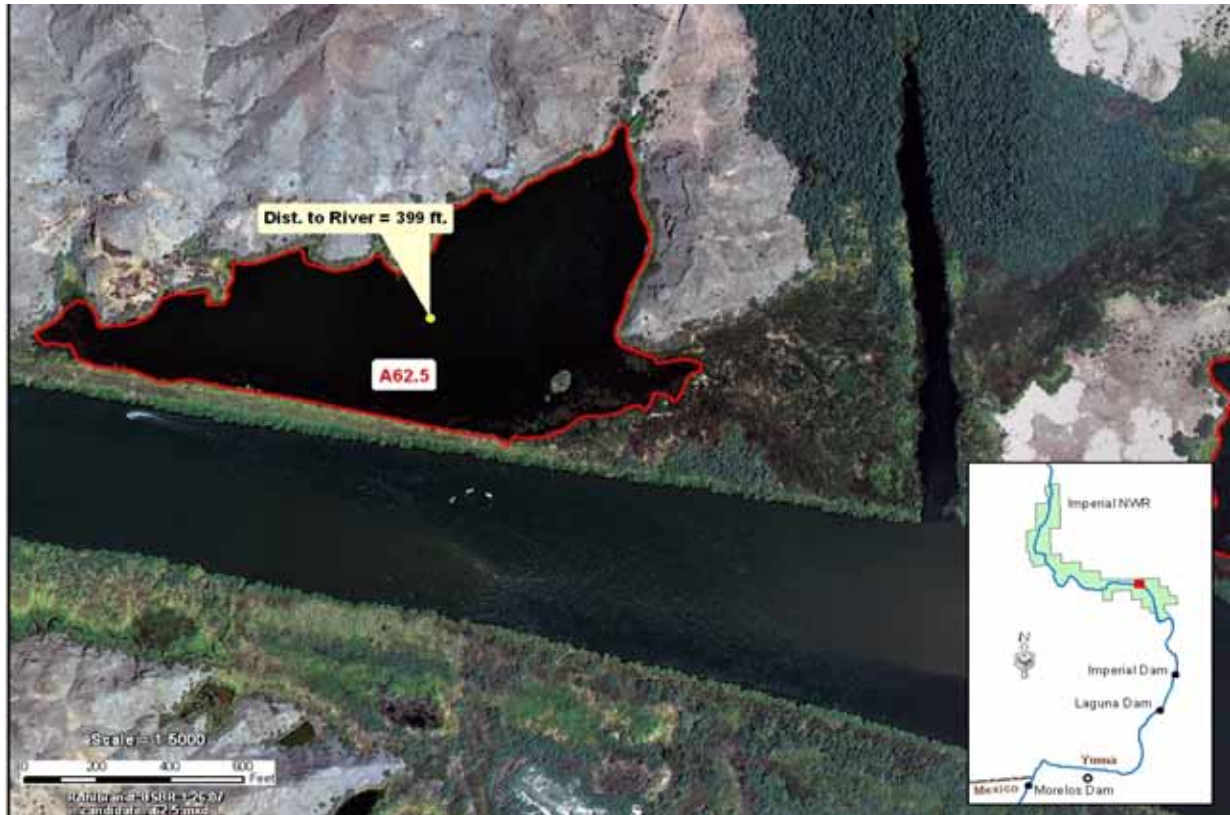
A62.5 Clear Lake is a directly connected backwater (17.0 ac) on the Arizona side of the Colorado River at river mile 62.5. There is no visible surface connection to the river during the helicopter survey; however, this backwater is likely connected during high flows. Because this backwater appears to be intermittently connected to the river it is classified as a pseudo seep.

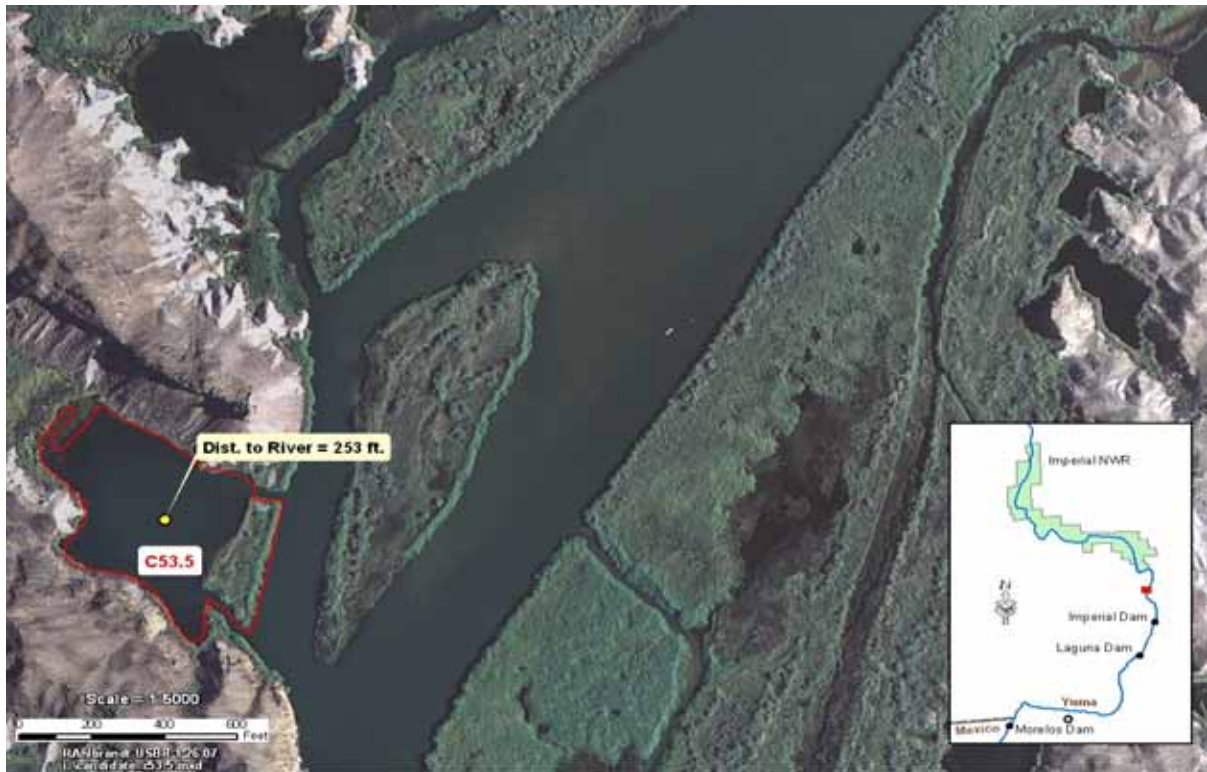
C53.5 is a directly connected backwater (6.4 ac) on the California side of the Colorado River at river mile 53.5. The backwater appears to have been possibly connected to the California Channel, which connects numerous backwaters to the Colorado River via a dredged inlet channel. Because of the connection to the main river channel, this backwater is classified as a connected lake.

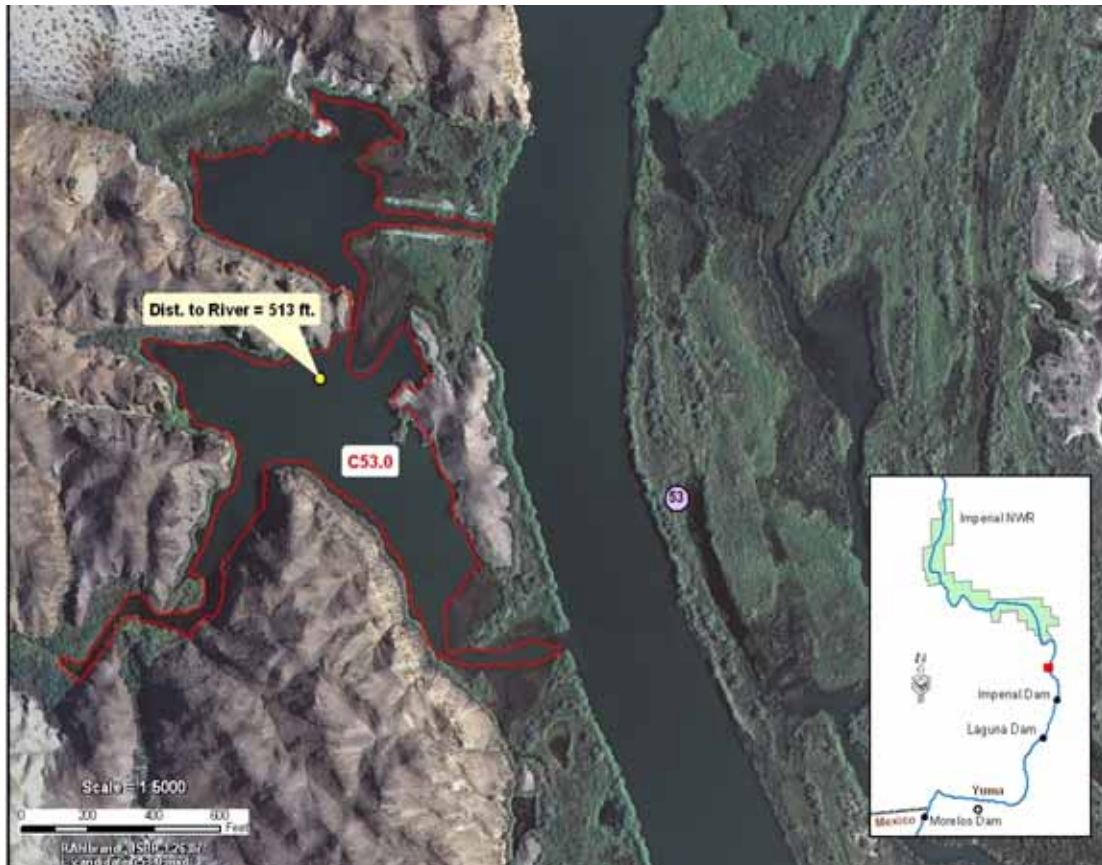
C53.0 is a directly connected backwater (14.2 ac) on the California side of the Colorado River at river mile 53. The backwater has two inlet channels (upper stream and downstream) that are accessible by boat. Water quality at this site is presumed to be similar to the river due to the two inlet channels; however, no water quality profiles were conducted at C53.0 during the helicopter survey. Because this backwater has two inlets to the main channel, it is classified as a connected lake.

Site access is limited to boat only. No road access was observed during the helicopter survey. Due to boat access from the river and close proximity to Squaw Lake, recreation pressure is most likely high in this backwater.

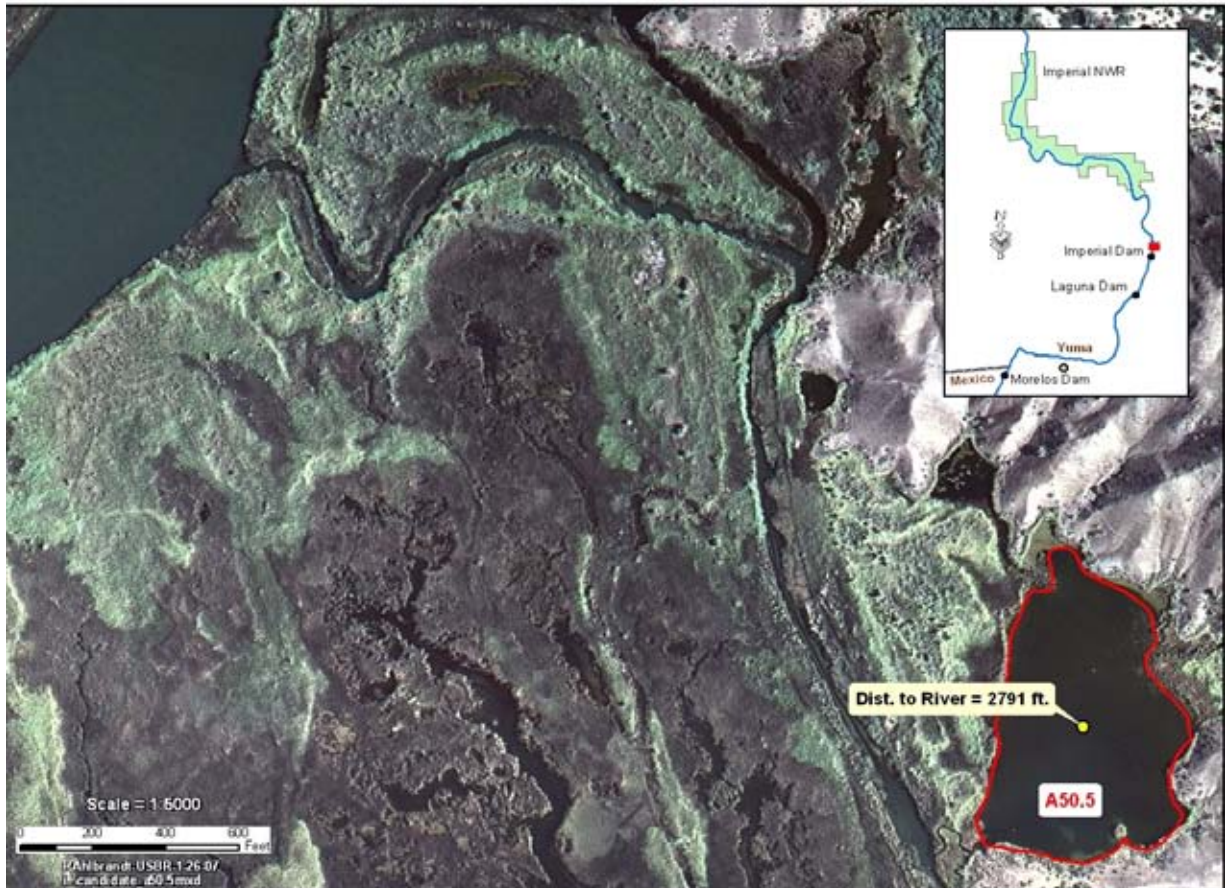
A50.5 is a directly connected backwater (8.0 ac) on the Arizona side of the Colorado River at river mile 50. The backwater appears to have been connected to the Arizona Channel, which connects numerous backwaters to the Colorado River via a dredged inlet channel. Because the backwater is connected to the river via the dredge channel, this site is classified as a connected lake.

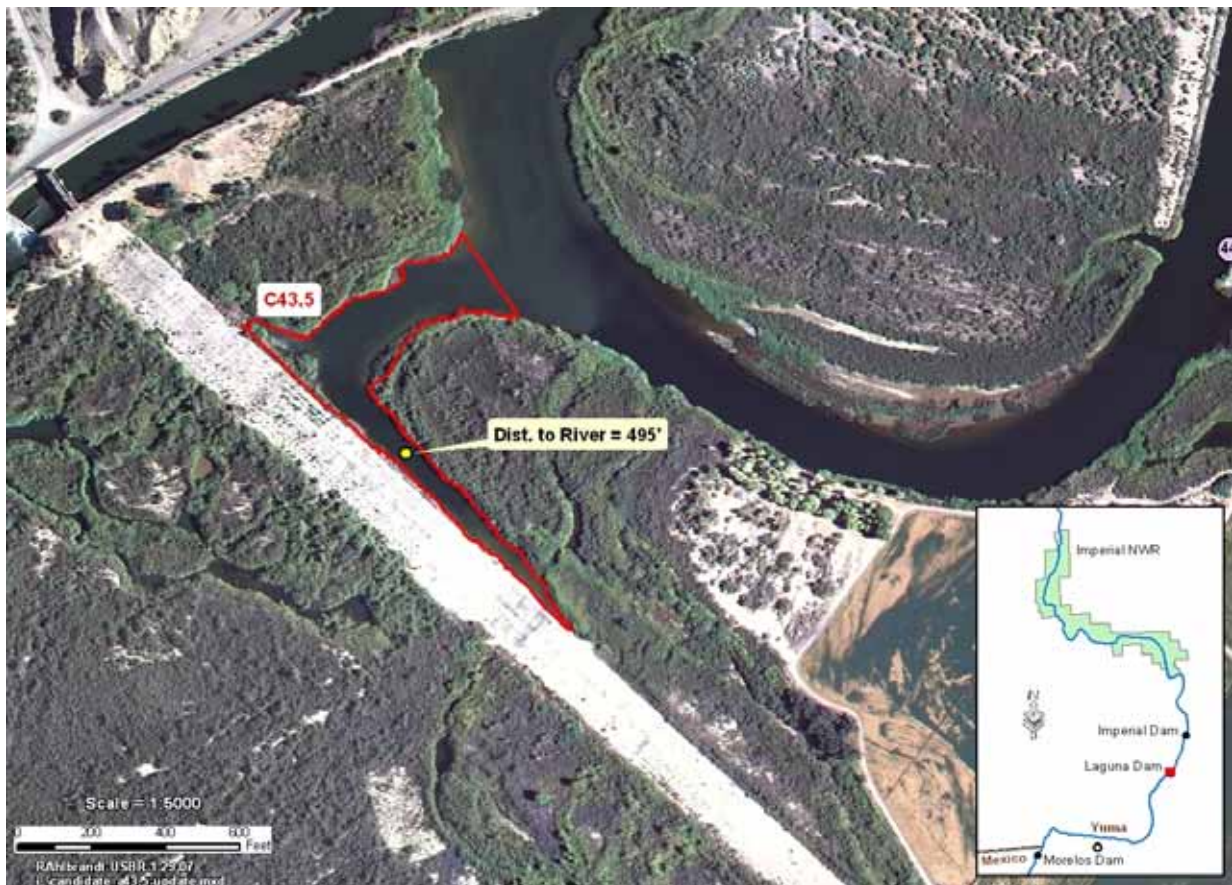
A43.5 is directly connected to the main channel of the Colorado River. This backwater (4.0 ac) is located east of Laguna Dam and west of the Pratt Agriculture Field. Water quality is expected to be similar to the main river channel due to a direct connection to the river. Because of the direct connection to the main channel, this backwater is classified as a connected lake. No water quality profiles were conducted at A43.5 during the helicopter survey.
